Post-test Facility at Argonne

DOE Annual Merit Review

ABR Deliverable – ACFF-B1A-PX
Integration of Testing and Post-Test Facilities

Analysis of ABR Cell
CGP-A12 Anode – Precipitates Are Seen in SEM Images

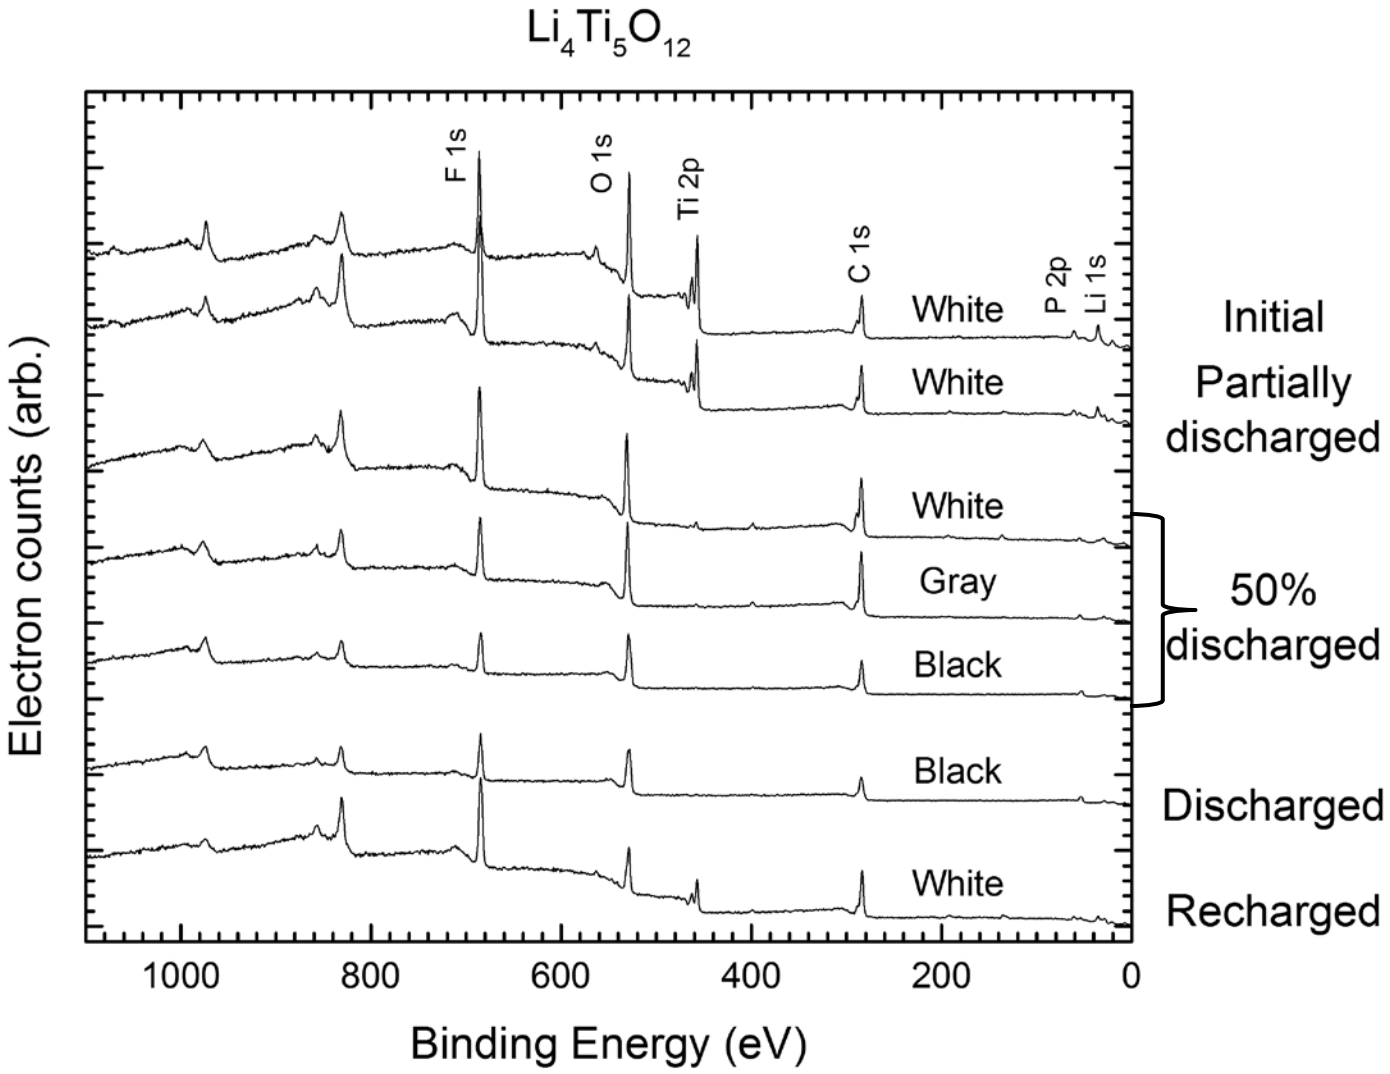
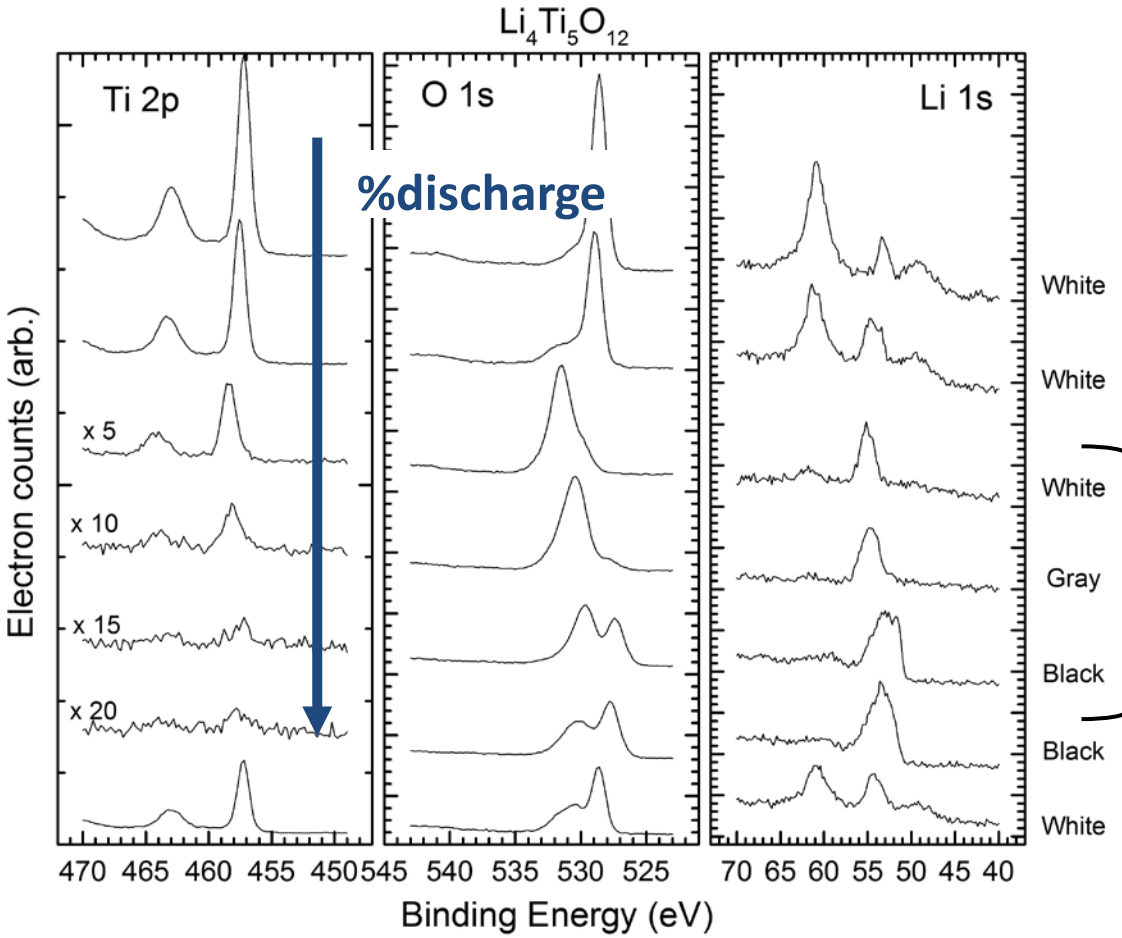
- Ti 2p peak disappears as material is discharged; it emerges upon recharge
- May indicate presence of an SEI layer which forms and dissolves with discharge and charge

- Low energy component in O1s peak, which stays after recharge.
- The state of discharge (amount of additional lithium) increases downwards, except for the last curve which is the re-charged sample. The intensity of the Ti 2p peak is inversely correlated with the state of discharge, consistent with formation of SEI layer that dissolves upon recharge.

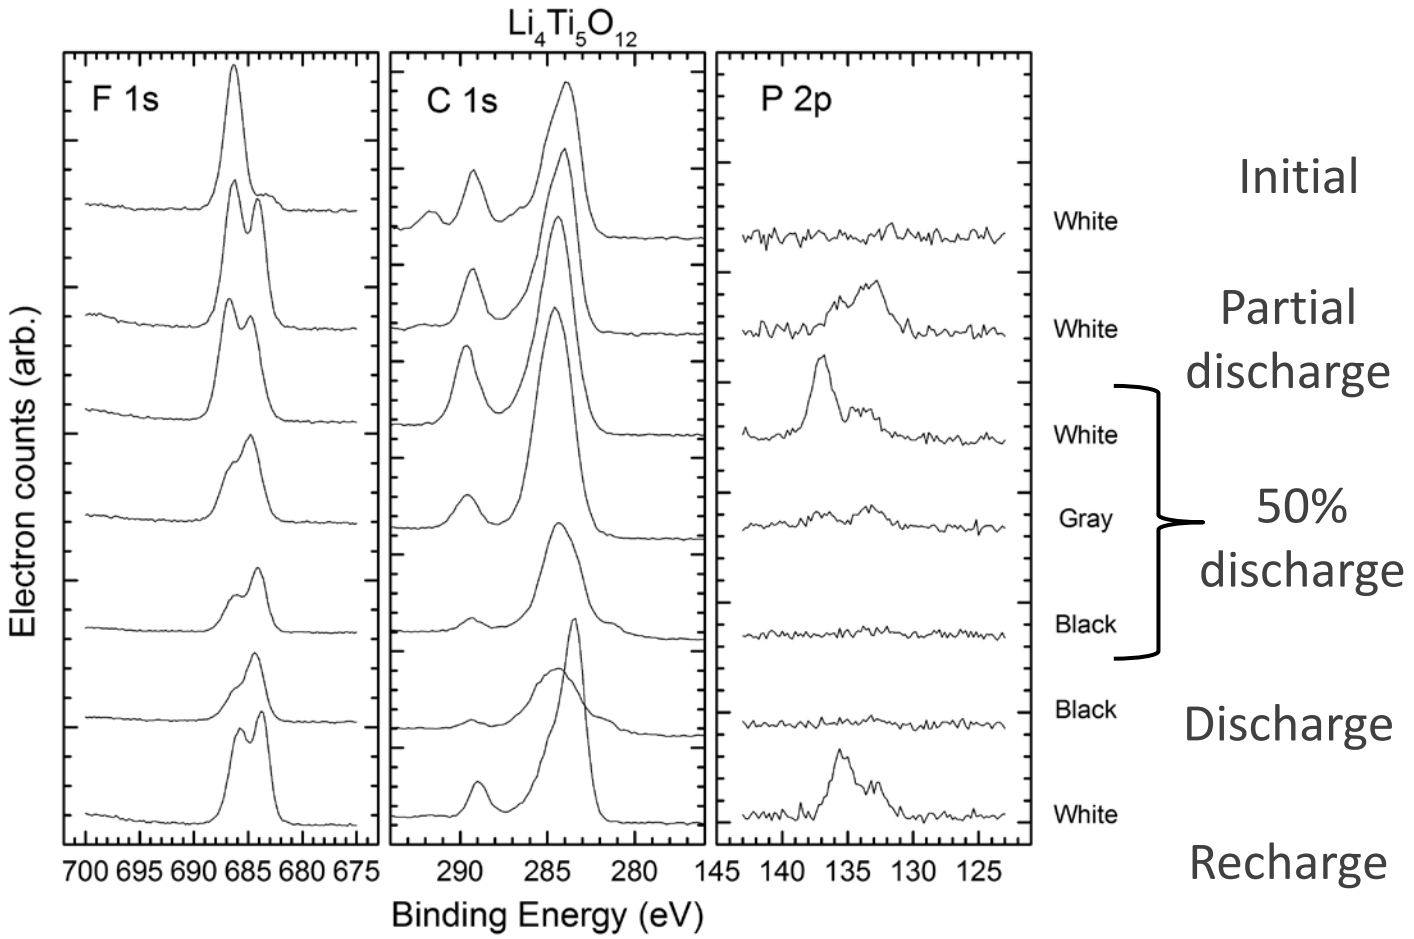
Other Changes Are Seen in XPS Results

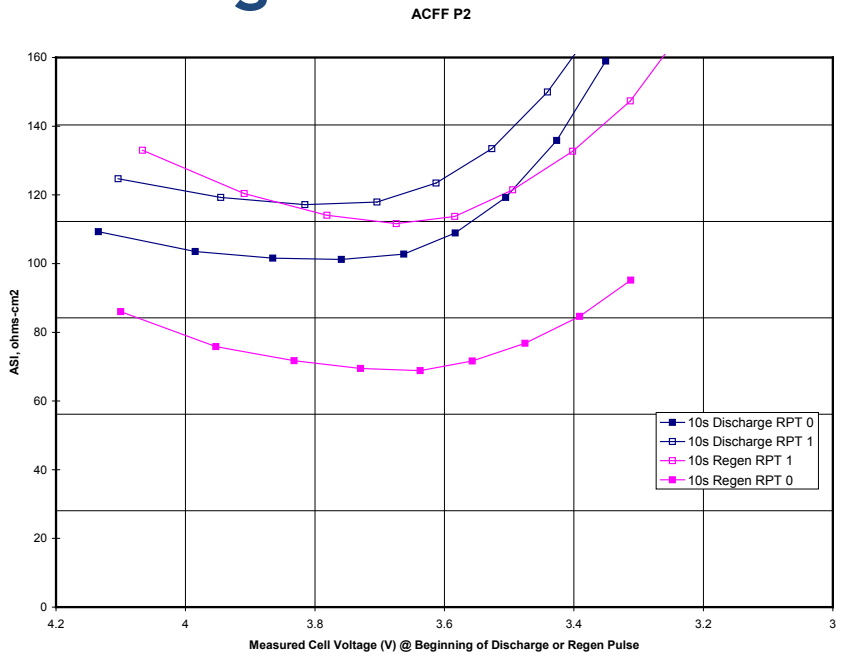
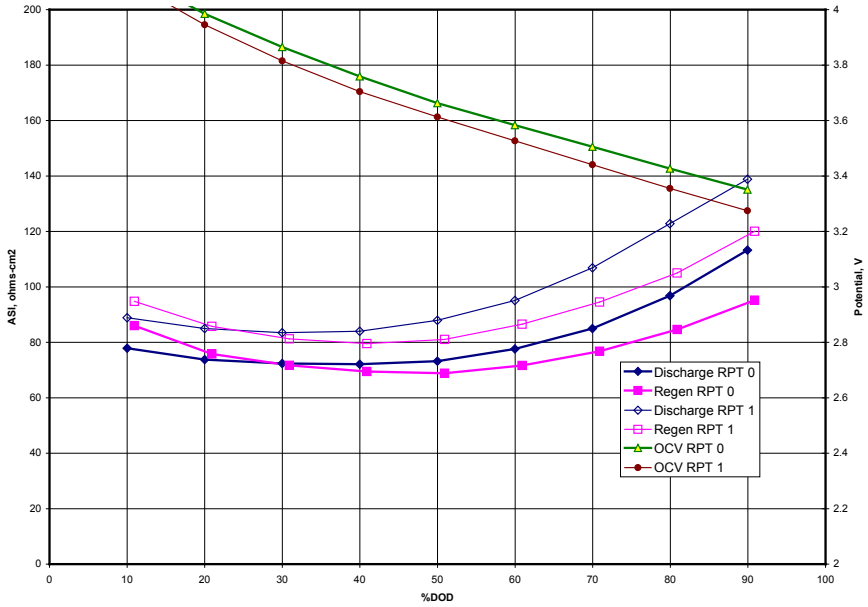
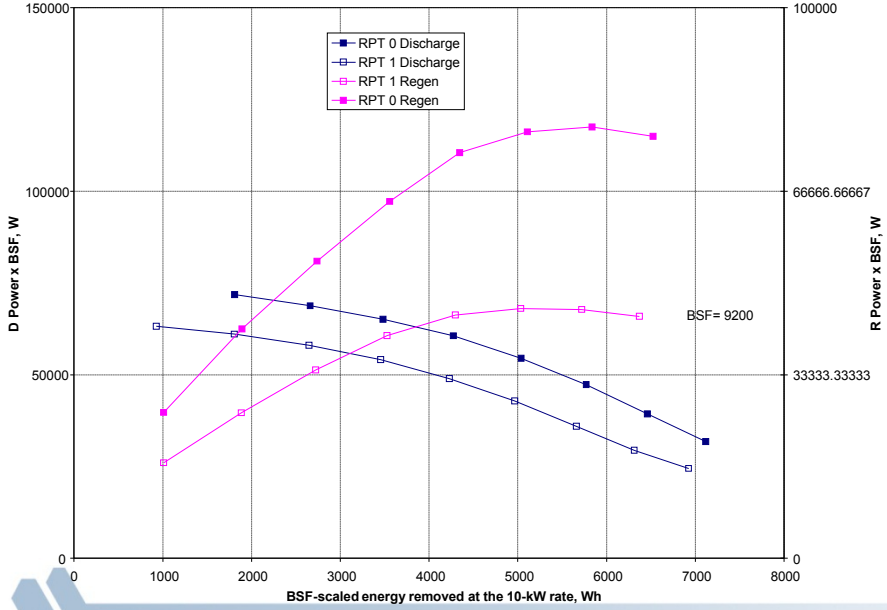
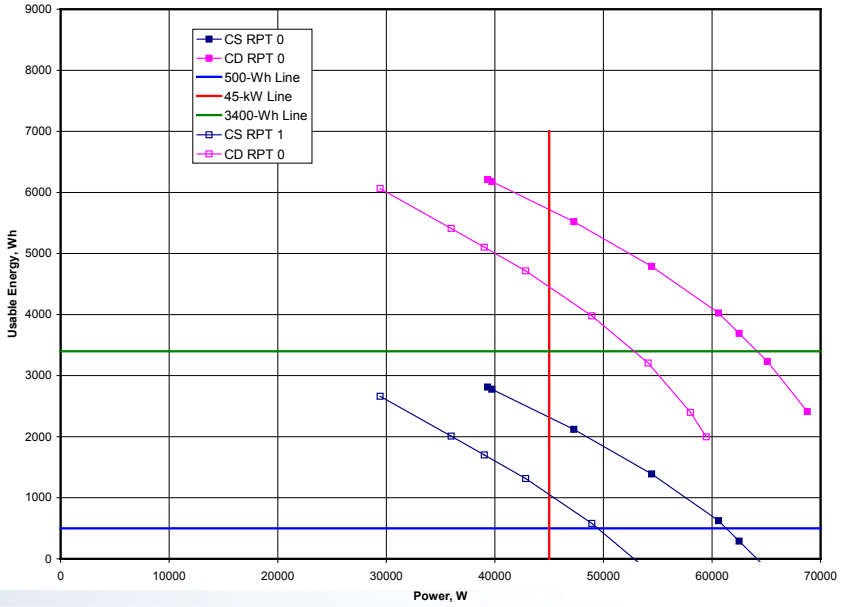
Changes in Cell Performance Are Seen With Cycling

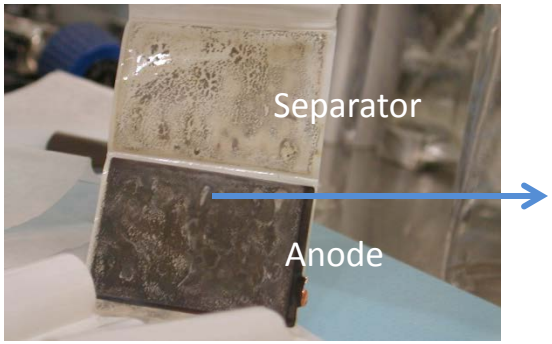
Unraveled cell pouch showing separator and anode.

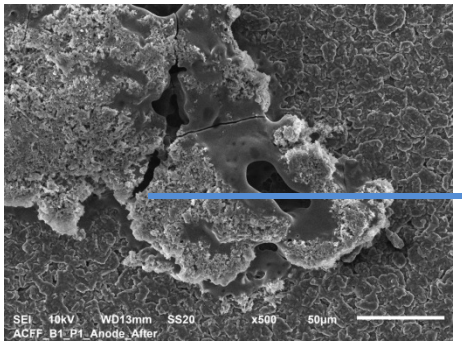
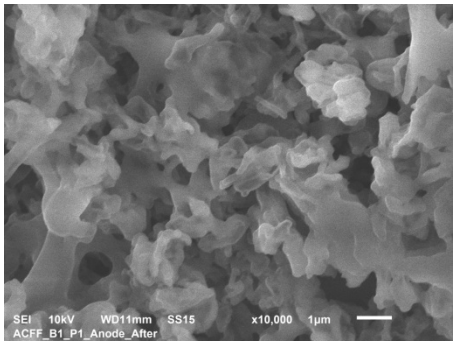
After rinsing with EMC, SEM images of anode surface showing extensive surface precipitates.

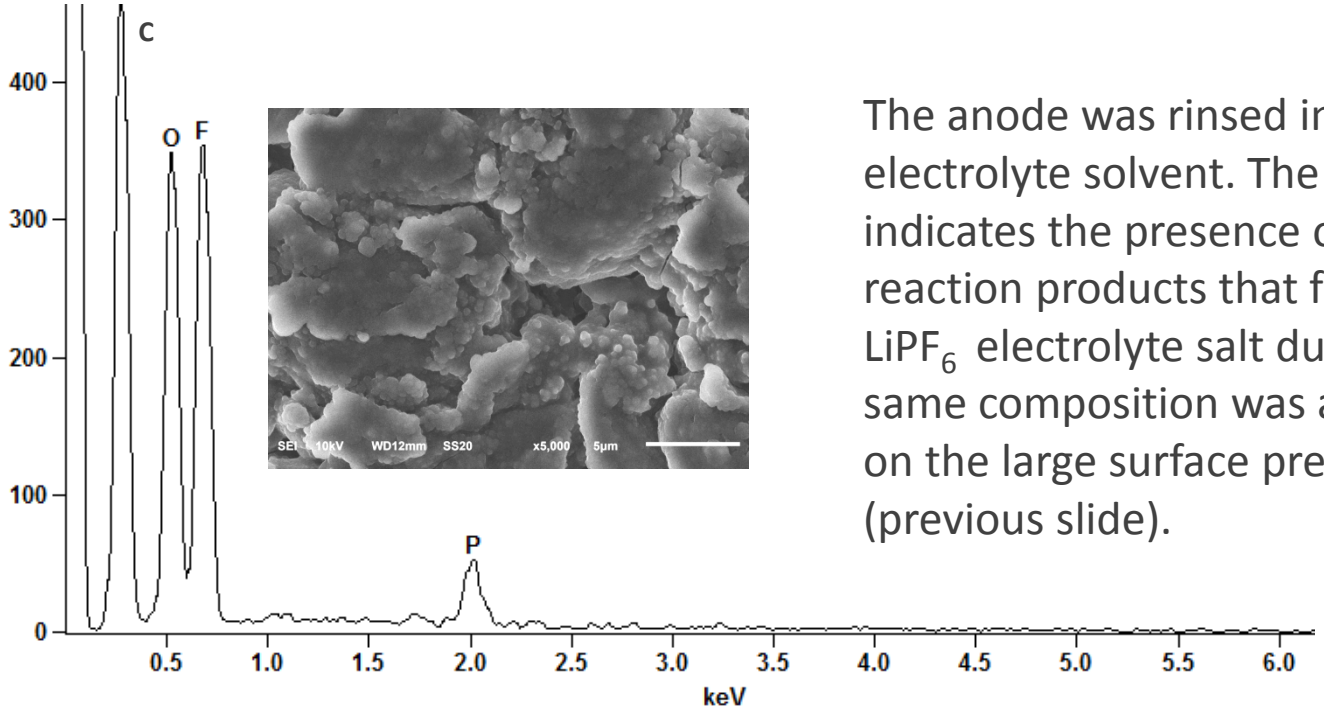
The anode was rinsed in EMC, the electrolyte solvent. The EDS spectrum indicates the presence of insoluble reaction products that formed with the $LiPF_6$ electrolyte salt during cycling. The same composition was also detected on the large surface precipitates (previous slide).

Note: Li is not detected by EDS

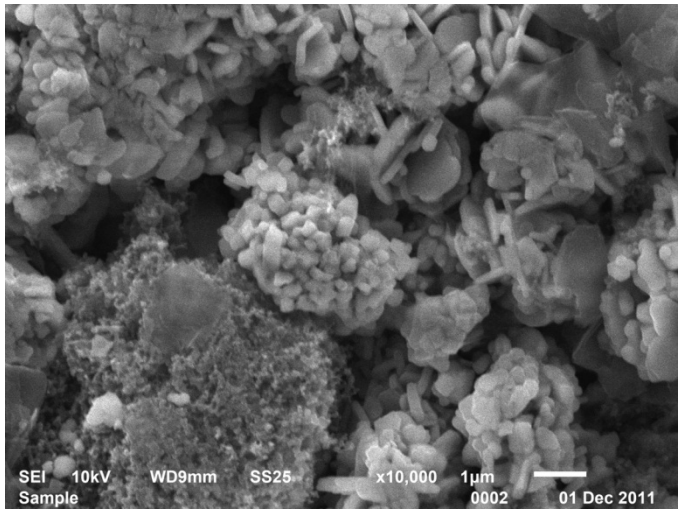
Surface *Before Cycling*

Surface images of the cathode show that there were no obvious microstructural changes due to cycling

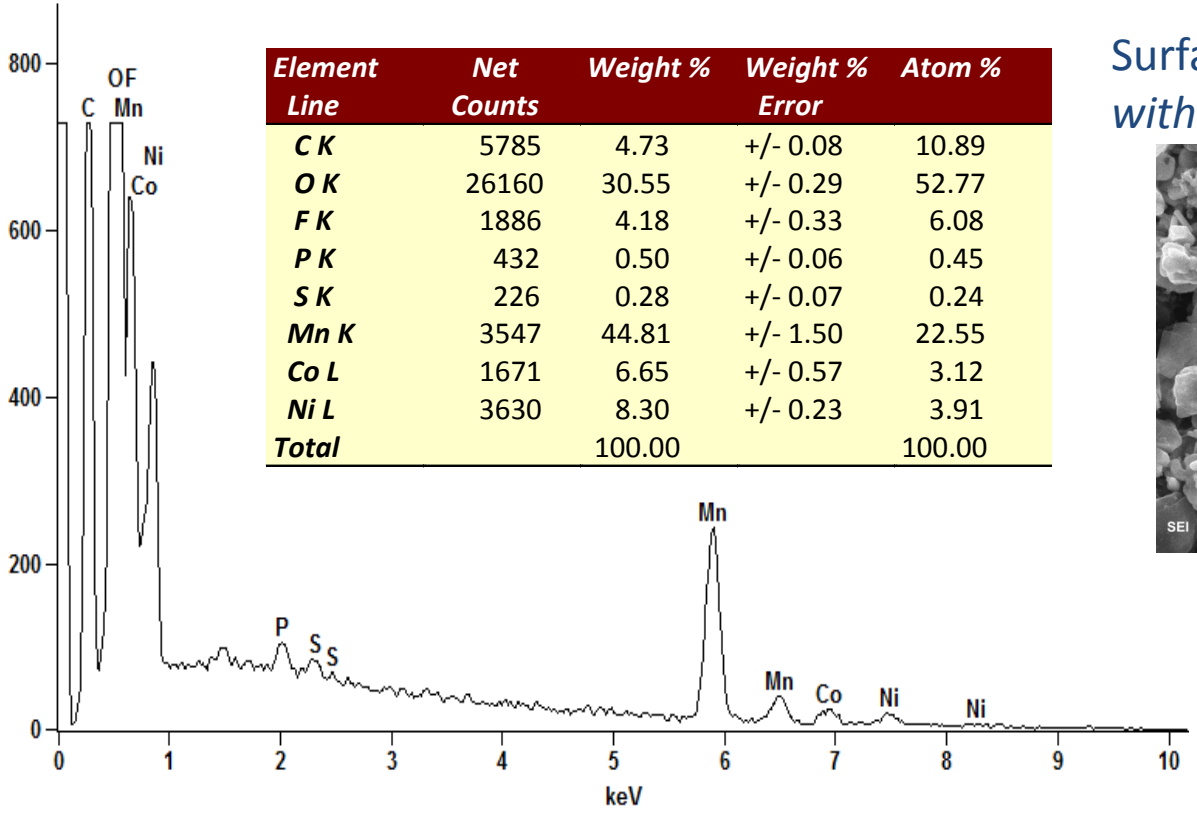
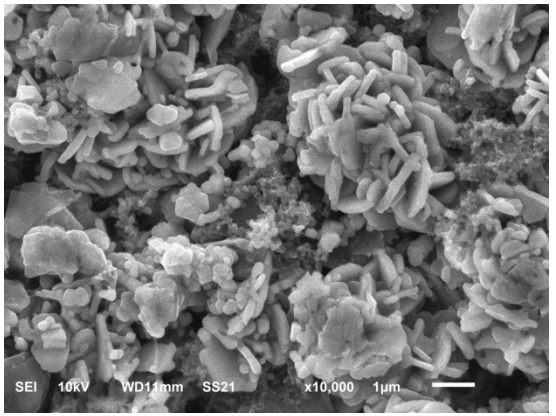
Surface - *After Cycling and Rinsing with EMC*

Representative EDS data indicates the presence of insoluble reaction products that formed with the $LiPF_6$ electrolyte salt during cycling. The oxide particles are produced in a sulfuric acid environment and, thus, is the most probable source for S.

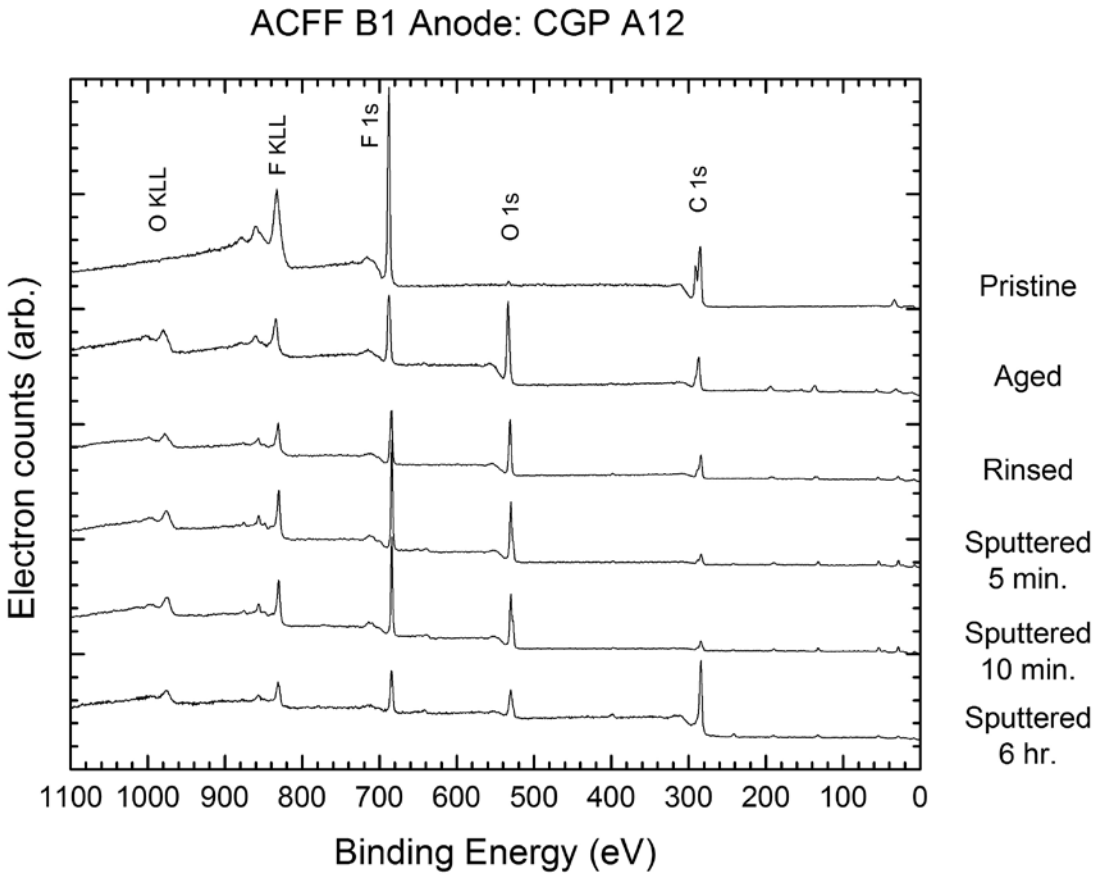
- Intense F1s peak decreases upon aging and rinsing and drying; recovers upon sputtering
- Continuous decrease of C1s peak

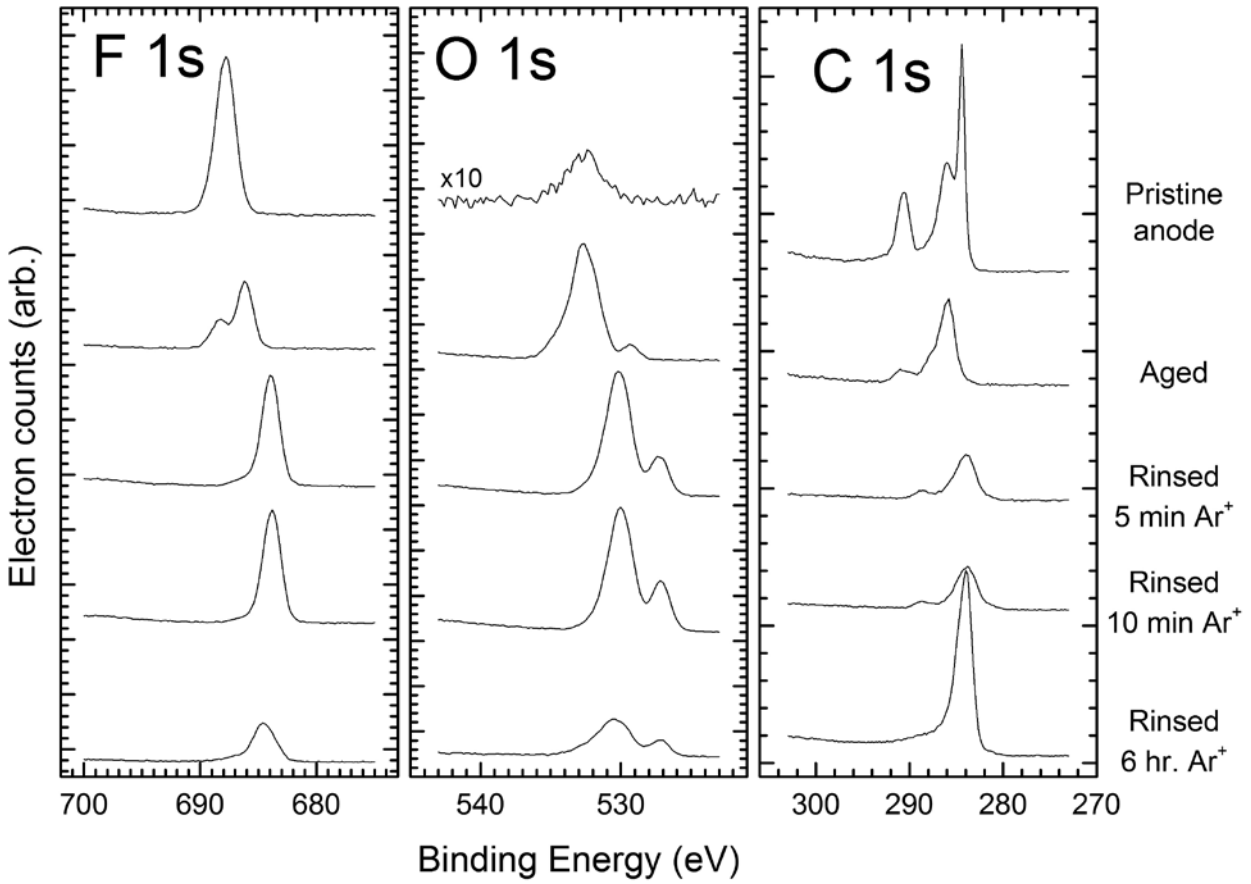
- Mn is present in sputtered sample
- Hard shift to higher B.E. of all regions in sputtered sample due to sample charging
- C1s looses sharp low B.E. component and broadens. Potential ion mixing
- High B.E. component of F1s forms upon aging; removed by sputtering
- Continuous development of low B.E. O1s component

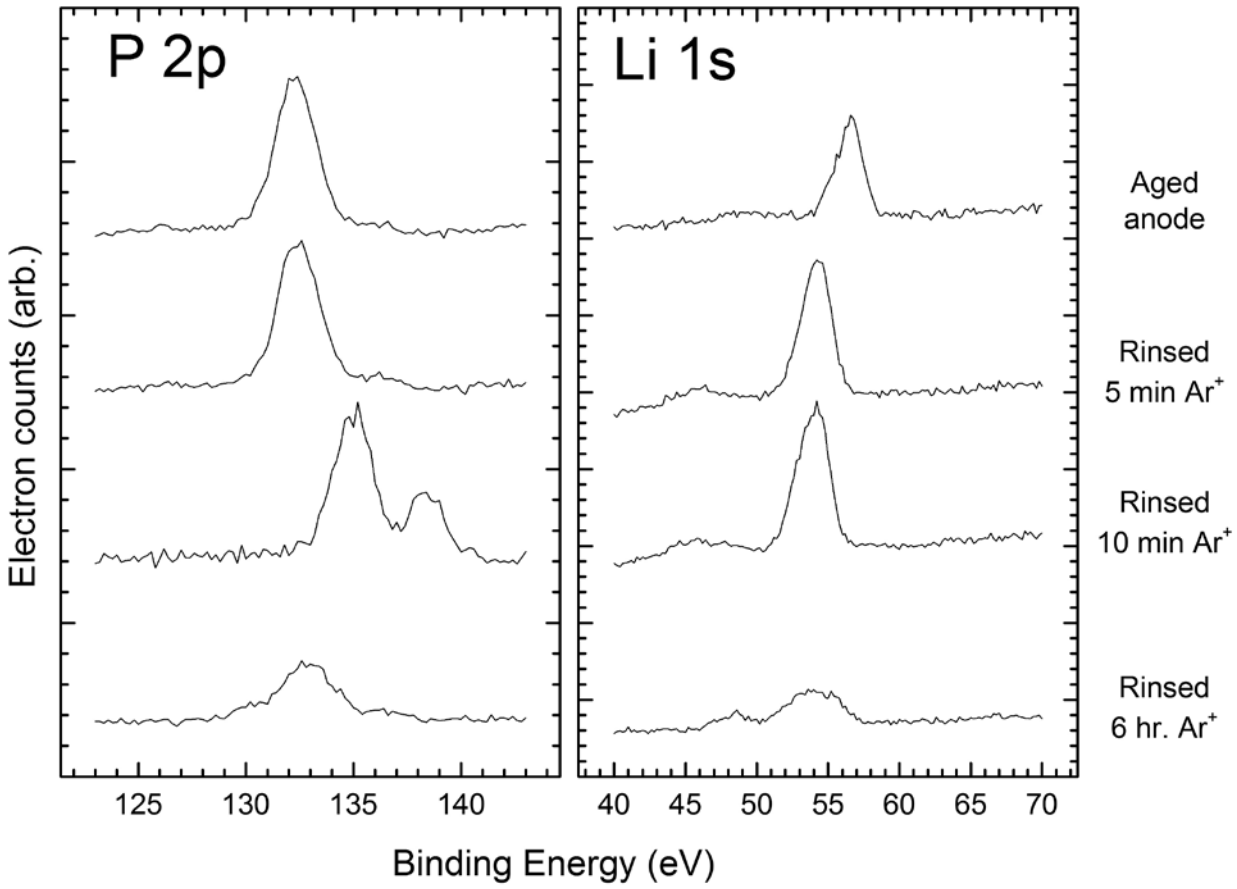
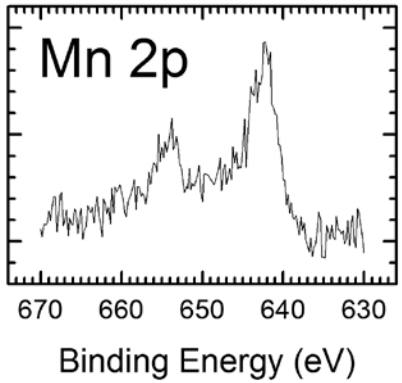
XPS analysis of CGP-A12 anode harvested from ACFF 1st cell build.

- No Li or P in pristine anode
- Li1s shifts to lower B.E. Less oxidized
- A high B.E. component appears in P2p

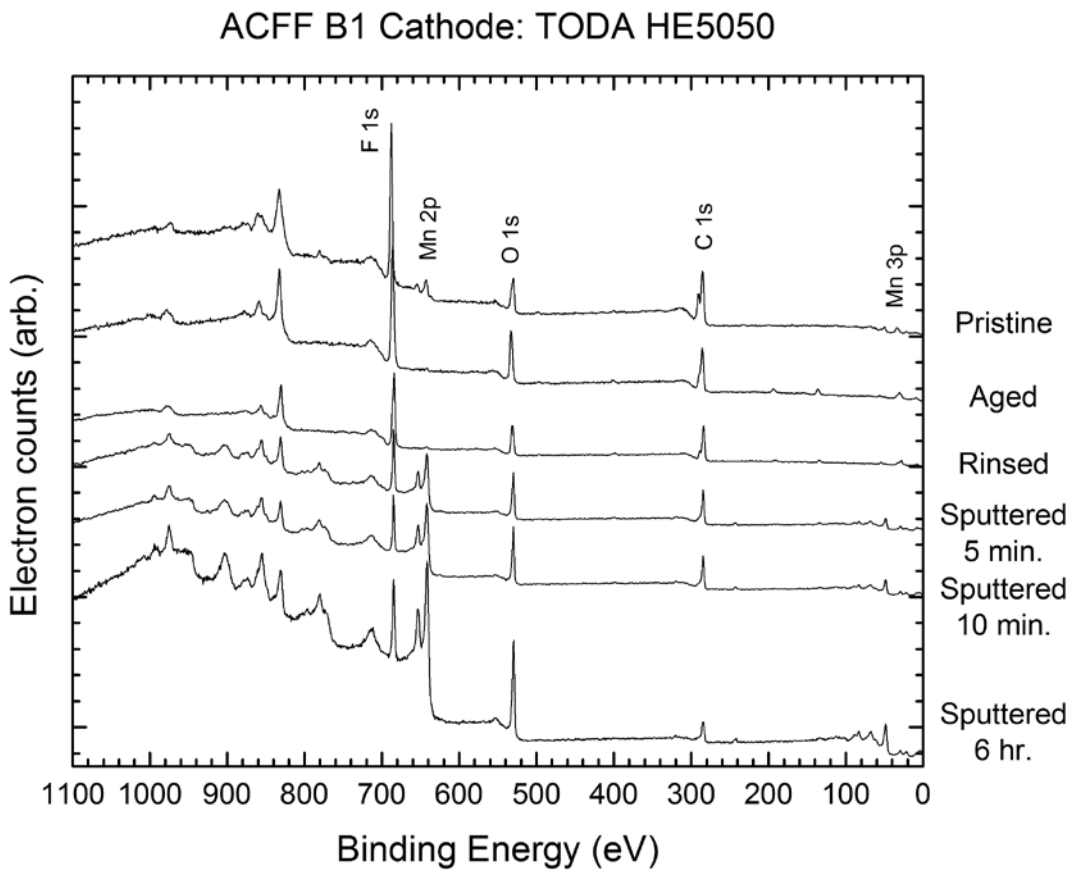
- Mn2p signal is lost upon exposure to electrolyte. Recovered after sputtering
- Consistent with presence of SEI or residue in aged sample
- Higher Mn2p and lower C1s signals in pristine than in sputtered sample indicate good conductive carbon coverage of active particles

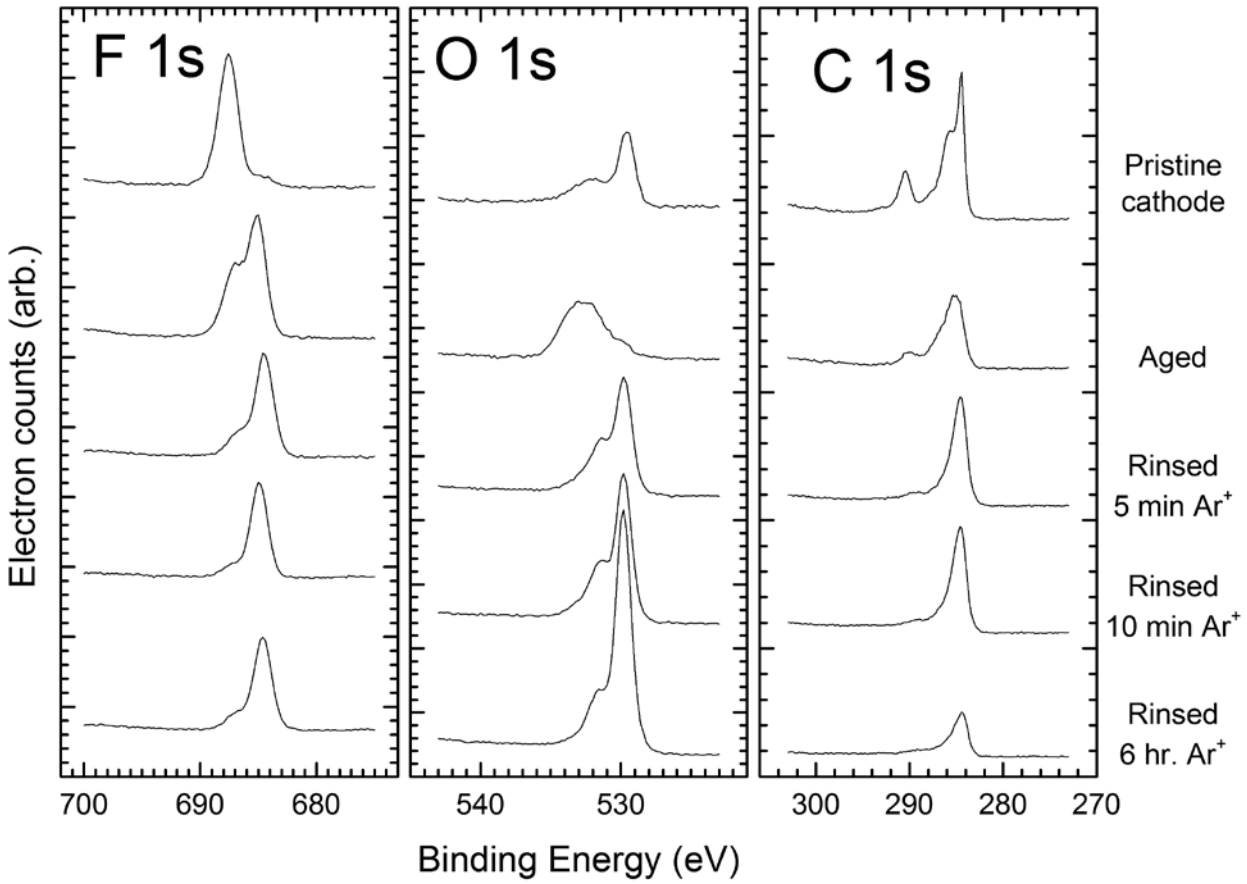
- F1s develops high B.E. component, diminished by sputtering
- O1s high B.E. component dominant upon aging and decreases with sputtering
- Lower Mn2p and higher C1s signals in pristine than in sputtered sample indicate good conductive carbon coverage of active particles

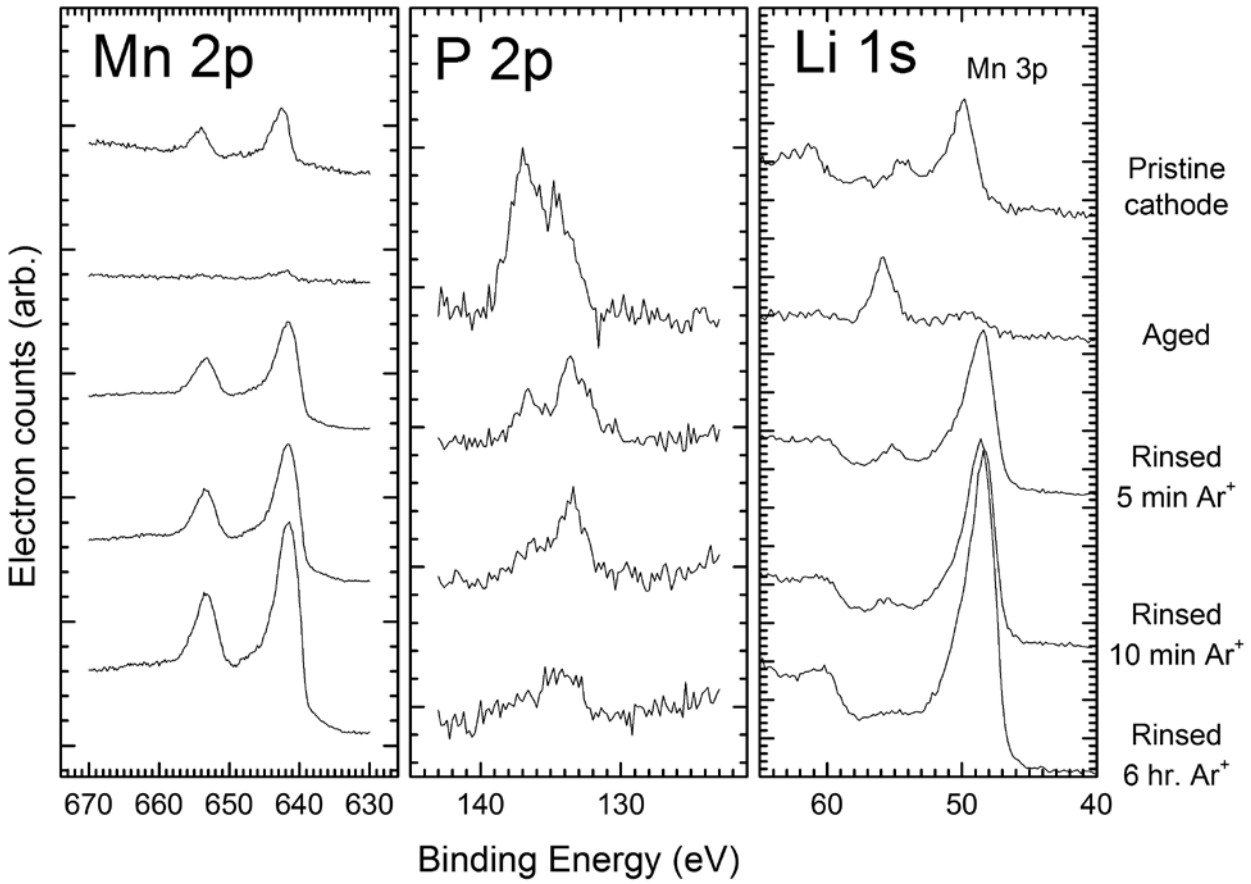
- Mn3p overlaps with Li1s
- High B.E. Li1s seems related to S.E.I. or deposit
- May indicate surface depletion of Li in active particles
